Manhole Inspection Summary

Manhole # S23KK1026MH

Insp Date: **11/6/06 3:25 PM**

Location Address: **1125 WOOD HEIGHTS AVE**

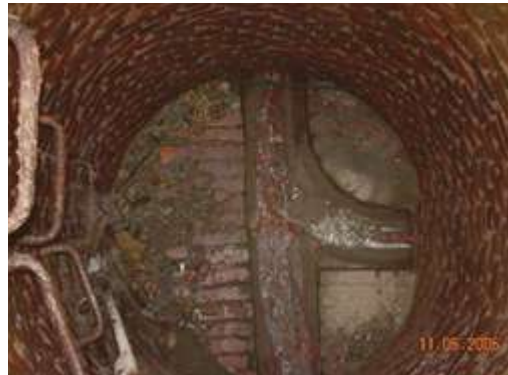
Top View

Adjustment and Barrel infiltration.
Corroded steps. Evidence of surcharge -
Bench debris.

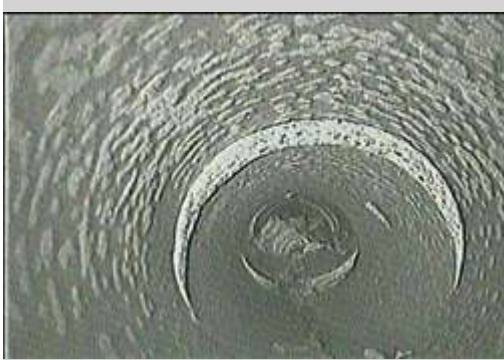
Inside the I6

Offset joints.

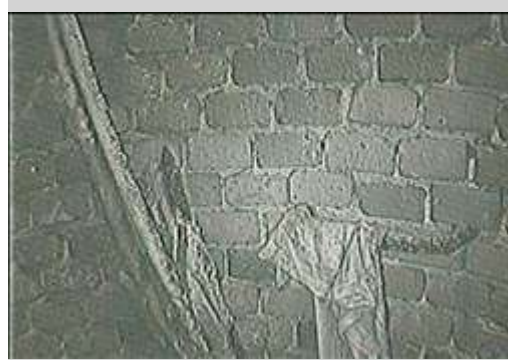
Defect

Evidence of surcharge.

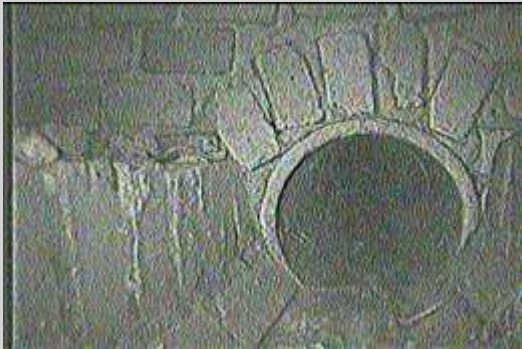
8 in. Circular Gravity Sewer Pipe Out @ 12 O'Clock

Infiltration: **None** Pipe Seal Cond: **Cracked**

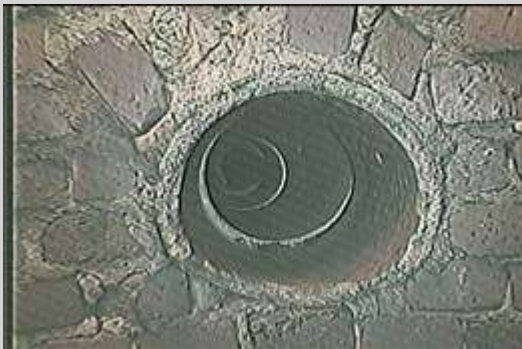
8 in. Circular Gravity Sewer Pipe In @ 3 O'Clock

Infiltration: **Evidence** Pipe Seal Cond: **Cracked**

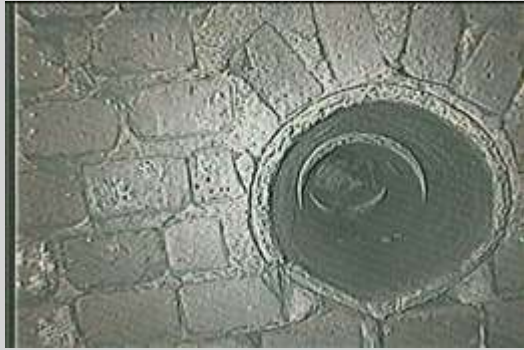
Pipe In @ 6 O'Clock

Infiltration: **Evidence**

Pipe Seal Cond: **Cracked**
